This highly modified, supercharged Holden VE Series II Commodore V8 was a trade job for a performance shop. It went through a large rebuild with them around six months ago and had since gone in and out of different periods of perfect running at 1000hp-plus track days, dead misfires, fuel-cut type symptoms and, for good measure, a new flywheel and bellhousing from an exploded clutch.

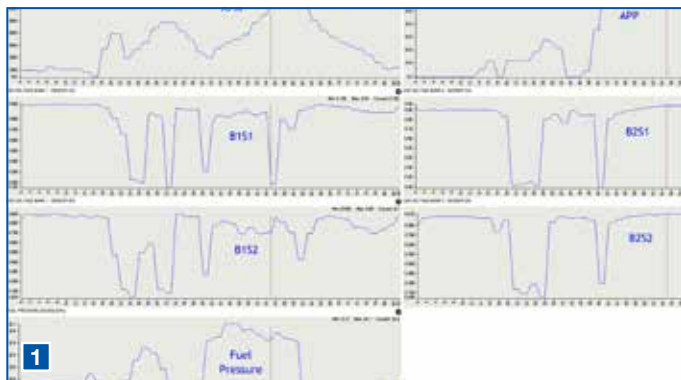
I started with my Snap-on Solus, which is my favourite scan tool for data-logging for deep analysis later on the PC. Midway into the wide-open throttle (WOT) pull, around 3500RPM, I dropped a cursor at the point the engine RPM started to falter (i.e. the point it started faulting) and clear as day I could immediately see that B1S1 sharply dropped lean while B2S1 remained rich as it should on a WOT pull (pic 1). So it seemed likely the fault related to bank one.

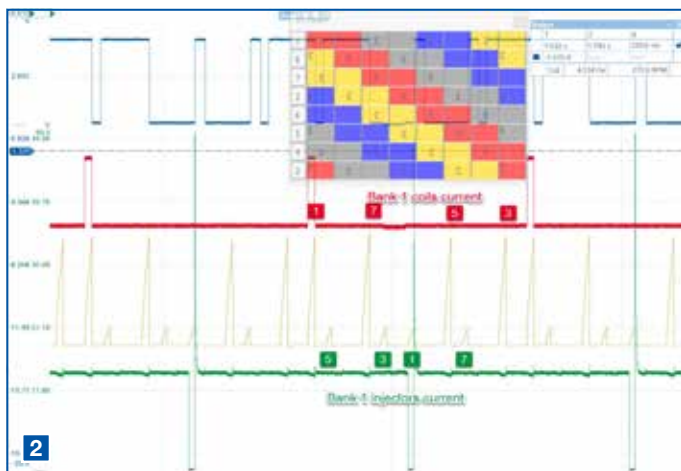
Pic 2 shows perfect running at idle, with the large yellow coil ramps being the coils and the smaller yellow coil ramps being the injectors on bank one.

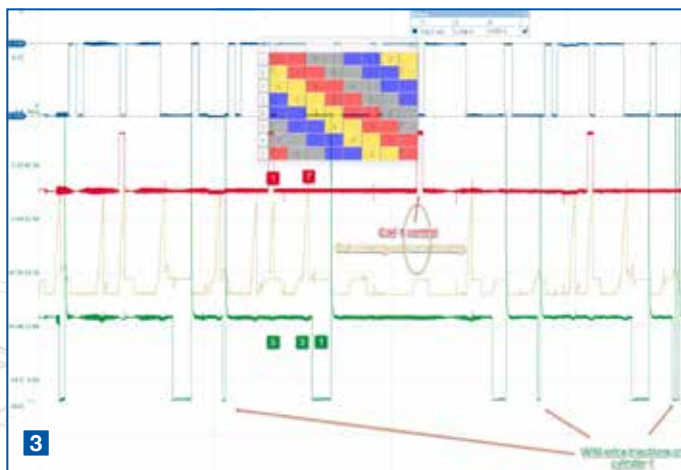
Roll on the load down the road and it bucked and kicked as repeatably as ever and the waveforms gathered were astonishing (pic 3).

Coil control remained steady but there were clearly some missing coil-current ramps when there was good control. Injection control was chaotic; some good longer duration high-load injections, some missing injection controls and even some random, non-rhythmic multiple injections on the same cylinder. (cont. p10)

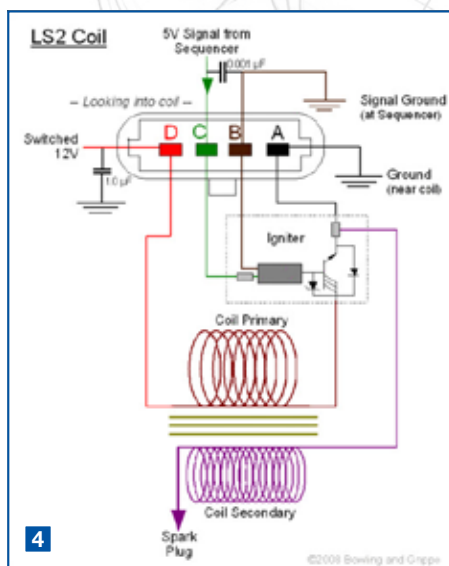
The four wire coils on this GM engine are a little different to others (pic 4). Left to right they have a power (D), a 5V transistor trigger (C), a dedicated transistor earth wire (B) – running a wire all the way back to the ECU to give a filtered ground, much like a sensor ground does – and a coil ground (A) to carry the hefty 10A or so of actual coil current. Three of the wires are shared by all coils on its respective bank, aside from pin C, the 5V transistor trigger, which is individual to each coil to fire at the correct time.

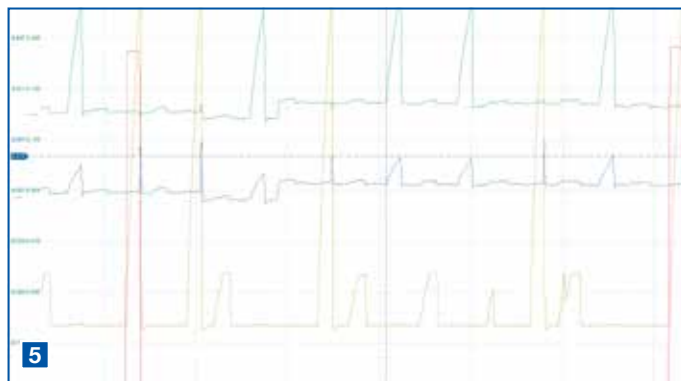
Focusing on channel A (blue) and channel C (green), there wasn't much activity on each bank's transistor earth during idle and low load. However, during the fault, large peaks started to form, particularly on the bank-one shared transistor earth, with some of the voltage drops (deviation from true earth zero volts) rising to more than 600mV (pic 5).

Such was the duration and shape of these voltage-drop ramps on the green trace, they could be mistaken for coil-current ramps if you hadn't been told what you were looking at.

While activity increased on the bank-two transistor earth during the fault, the ramps it displayed were predominantly mini versions of what was happening on bank one during bank-one coil events – I would suggest these were actually bank-one fault events making their way electrically onto the bank-two circuit.

With direction now, I used a borescope to follow the loom down behind the engine and – bullseye! – out of the thick wiring loom at this point exited one single-inch long wire, with an exposed wire end, resting on an empty thread in the head where a crimped earth lug should obviously be. The wire was making a decent earth connection at idle but

I'd love to say I could explain the knock-on effects of this poor coil earth but my knowledge only extends so far. It looked like the current went looking for a different path, finding its way into the coil transistor earth, causing the large voltage drops as the tiny wire struggled to deal with far more current than it was intended to.

With a back probe in the accessible bank-one harness connector main coil-earth pin, I ran a jumper wire and alligator clip to the engine block. Rolling on the throttle, for the first time I felt the full output of this engine, which prompted a passing pedestrian to seemingly ruin his undies as he mimed what must have been a plunger on his forehead while yelling something along the lines of 'Banker!'... all as he disappeared in the rear-view mirror.
